12 storey tower fully restored for 2011

Stone arcade on brink of collapse

Undermined garage causes partial retaining wall collapse

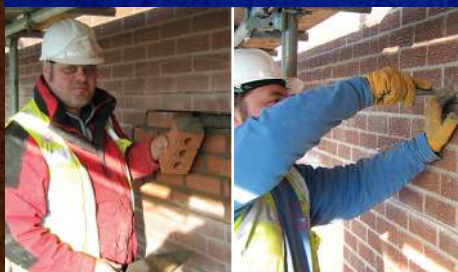
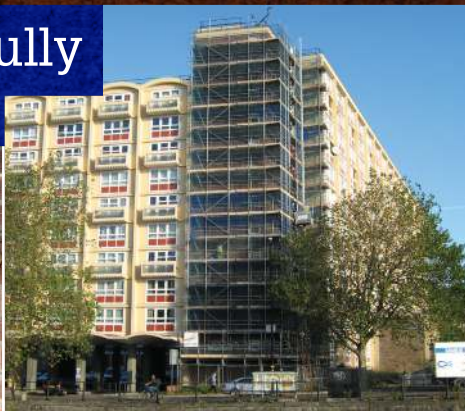
ASRS were asked to investigate and provide a solution to the connecting tower between two residential housing blocks, that had suffered from cracking and movement, as part of planned maintenance by a housing association.

An extensive external survey of the masonry was carried out, it was discovered that the brick slips were failing, some areas had cracked due to the structural loads and some areas needed to be rebuilt.

Three bed joints per floor were reinforced creating helibeams in the masonry which were wrapped around the tower to distribute

the structural loads and reconnect separating masonry. Specialist remedial wall ties were installed to pin the brick slips back to the concrete floors. Each brick slip was pinned back using a resin fixed tie with a total of 174 ties per floor. Areas of brickwork that were beyond repair were removed and replaced and then brick tinted to match the existing to provide an almost invisible repair.

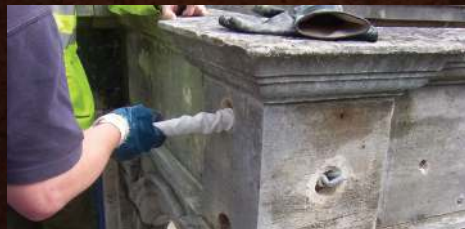
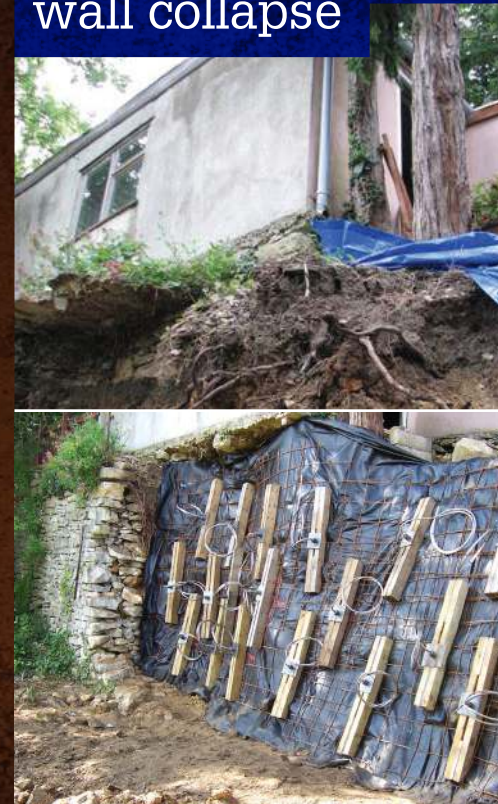
Due to a partial collapse of this retaining wall ASRS were asked to design a permanent solution to stabilise the ground.

Firstly the slope / cut face had to be restrained using platipus anchors, A142 mesh was fitted to timber noggins to restrain any further soil movement.

As the wall was reconstructed the anchors were incorporated into the new retaining wall to prevent any further movement. The wall was rebuilt using locally sourced stone and traditional lime mortar pointing restoring the original aesthetics of the wall.
