Designed Micro Cement & Lime Grout Anchoring Solutions

CINTEC

Design Concepts

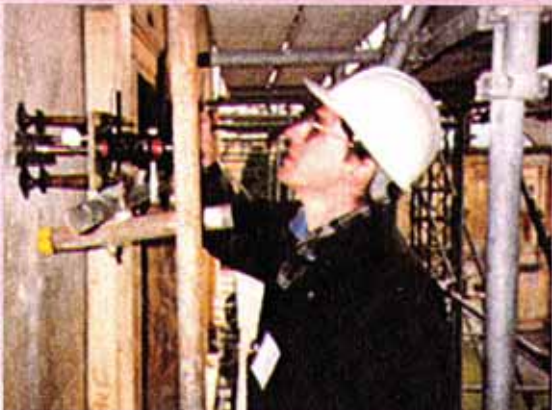
On location tensile load testing in Sandstone

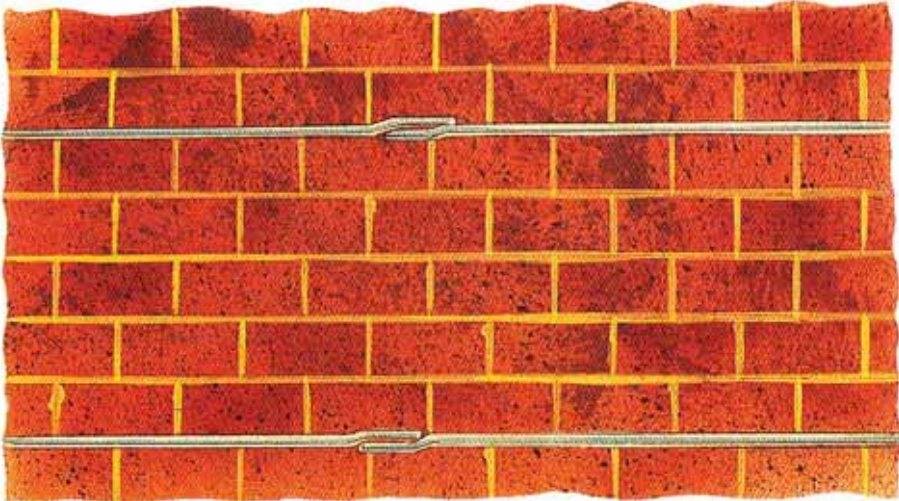
Raked out joint to 50mm

3mm stainless steel wire with crimped indentations

Expanded sock

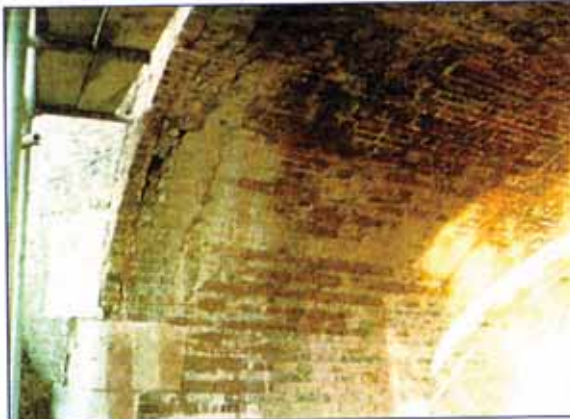
Typical damage to the soffit of the bridge

The most recent remedial work involved the repair of cracking in the brickwork. The concentration of the damage in the two side spans of the three span bridge suggested that the initial cause was possibly impact loading towards the ends of the bridge before the 'hump' was levelled out in 1982. This impact loading will have had the effect of forcing out the spandrel walls. Frost damage during the cold winters of 1986 and 1987 and washing out of mortar have further developed the initial effects. This has led to cracking of brickwork adjacent to the arch voussoirs, some movement in the spandrel walls, and delamination of the wing walls at the south end.

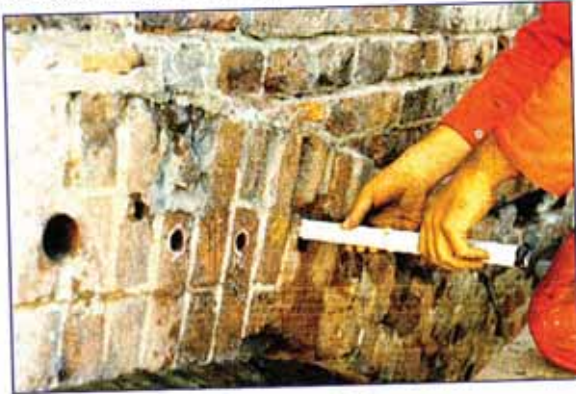
Placing the anchor in the prepared hole

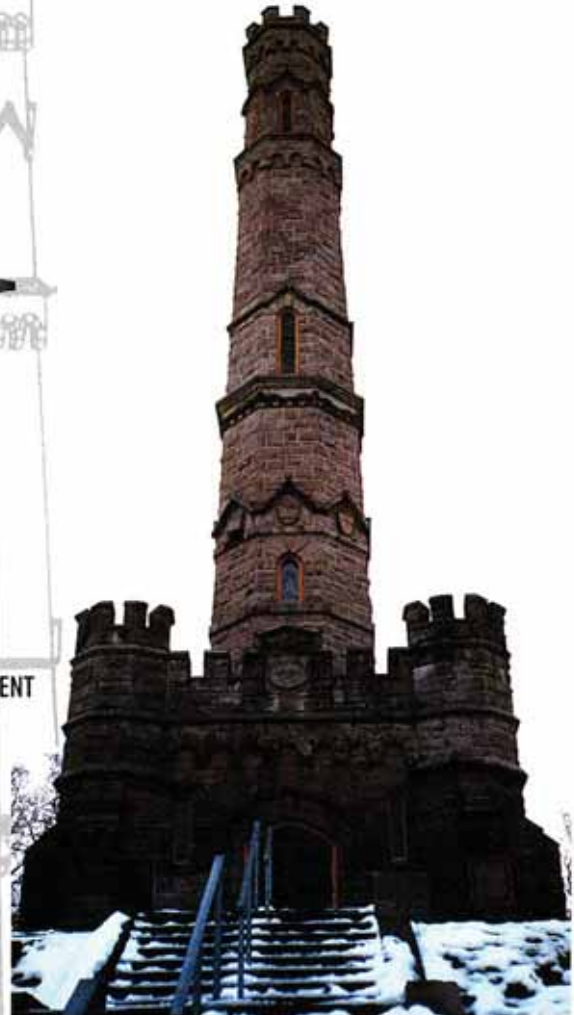
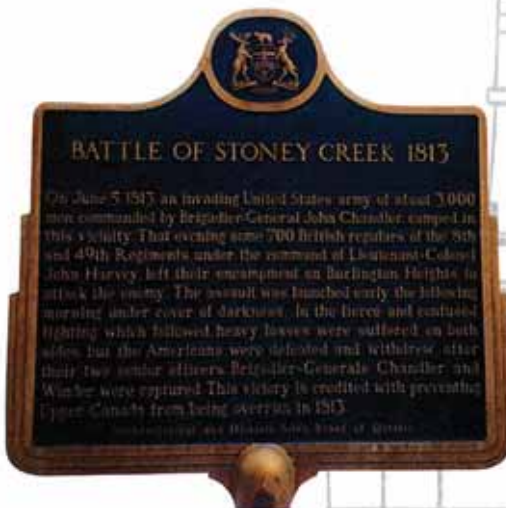
STONEY CREEK BATTLEFIELD MONUMENT
TYPICAL SECTION DETAILS THROUGH
UPPER TOWER WALL FLOORS 11/12

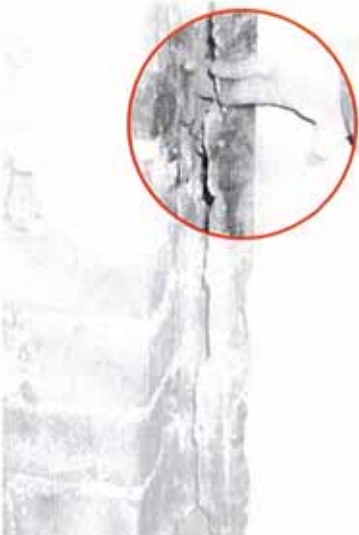
Remedial anchors installed prior to the fire. The anchors are still functioning. The grout cover protected the main steel body of the anchor.

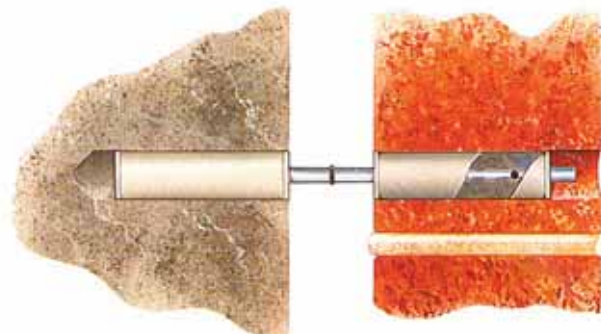
Supplementary wall tie

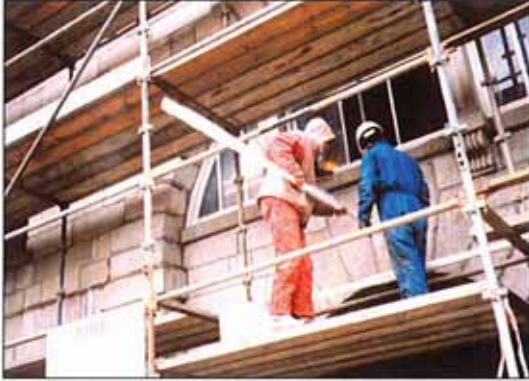
Anchor insertion approx 680 - 650mm x 10mm stainless steel anchors for facade retention

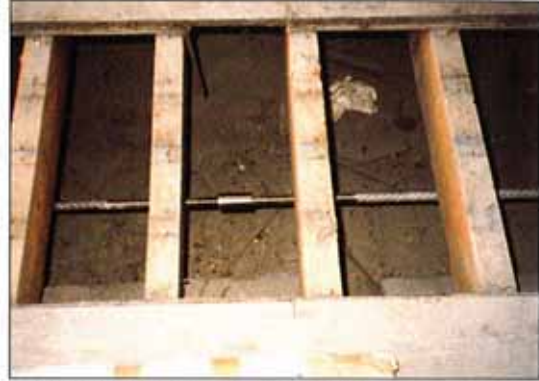
East block front and back arch tied with anchor assembly running from front arch to rear through floor

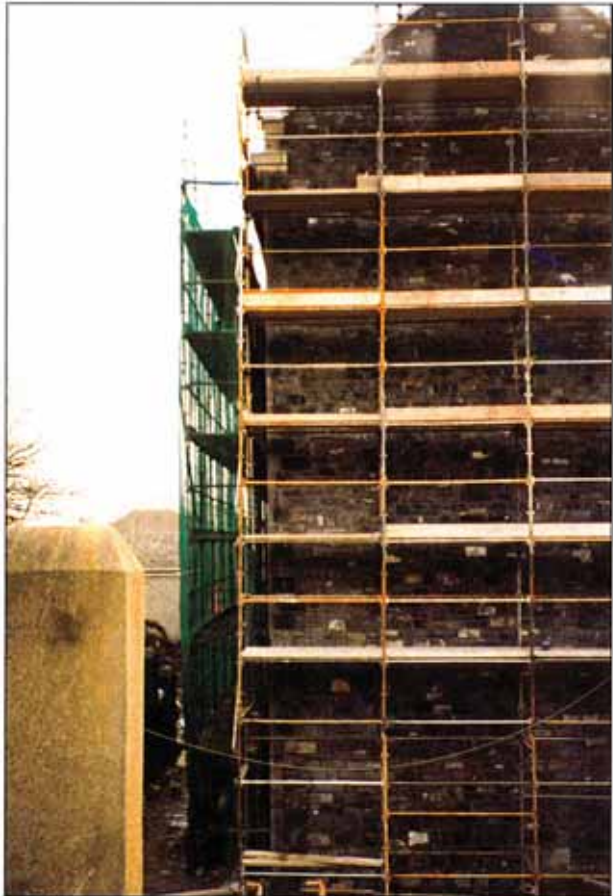
4 - 1800 x 30mm and 4 - 2200 x 30mm stainless steel anchors were used to stitch crack vertically up a five storey gable wall

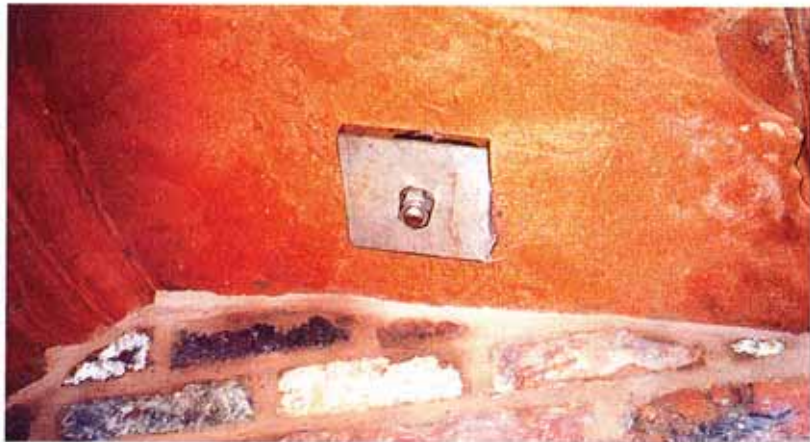
Roof bolt support to ballroom ceiling.

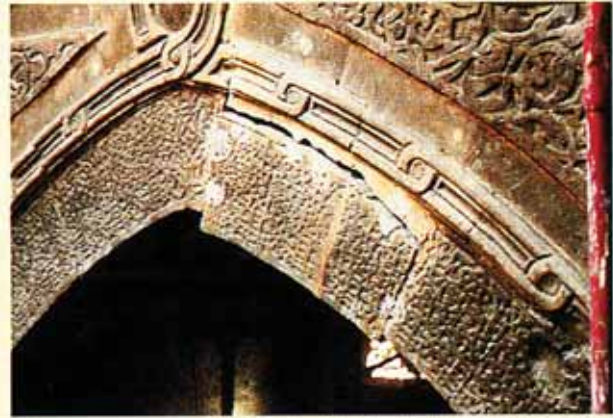
Seismic damage to decorative arches

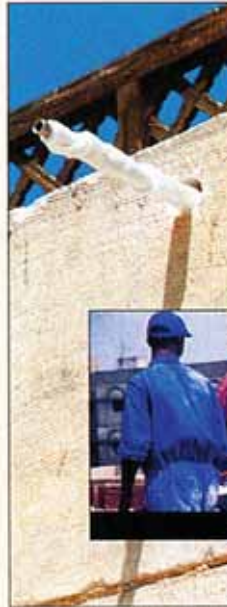
typical consolidation anchor prior to grout injection

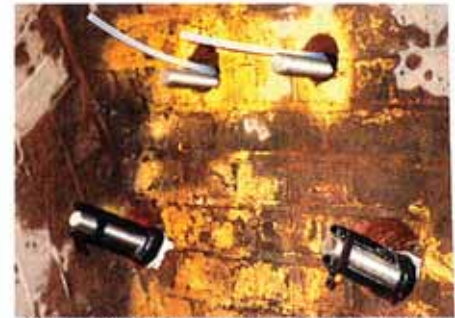
Shear anchors shown at the top and tension anchors at the bottom
